**CRUMBLING CONCRETE  
GARFIELD ELEMENTARY SCHOOL  
REPORT AND BLUEPRINT FOR ACTION**

RE: Preliminary Report - Crumbling Concrete Walls - Basement of Garfield Elementary

## PRELIMINARY REPORT - CRUMBLING CONCRETE GARFIELD ELEMENTARY SCHOOL

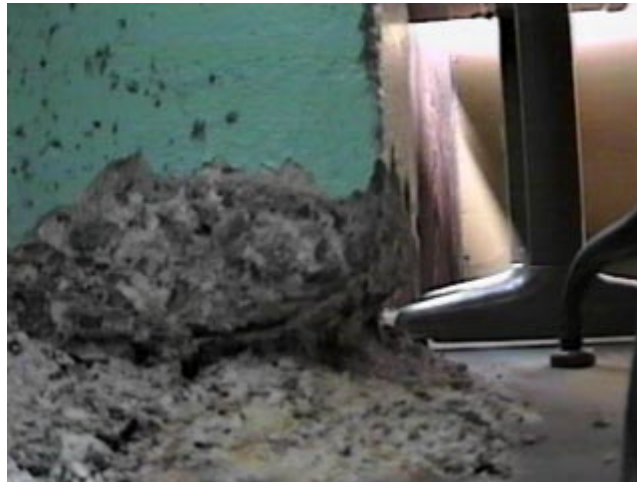
**PHOTOGRAPH NO. 1** - Crumbling concrete column in basement of Garfield Elementary.

Garfield Elementary School has a water problem. Its symptom is crumbling concrete. **Brim** found the basement level is encompassed by moist silty clay and silty fine sand. These moist soils are very corrosive and cause a reaction with the concrete. The water “flows” through the soil and picks up alkali minerals. See photograph No. 2.

1. Replace concrete window wells.
2. Waterproof exterior of concrete walls around perimeter of building.
3. Slope ground surfaces away from building and remove sandbox.
4. Replace concrete floors in basement - add vapor barrier and capillary break.
5. Restore interior concrete walls.
6. Install a new storm sewer line. This will separate the roof drain lines from the sewer lines.
7. Make the rest of the building envelope watertight.
8. Implement effective exterior maintenance program.
9. Make all trades aware of building envelope waterproofing requirements.
10. Schedule inspection programs to stay on top of maintenance.

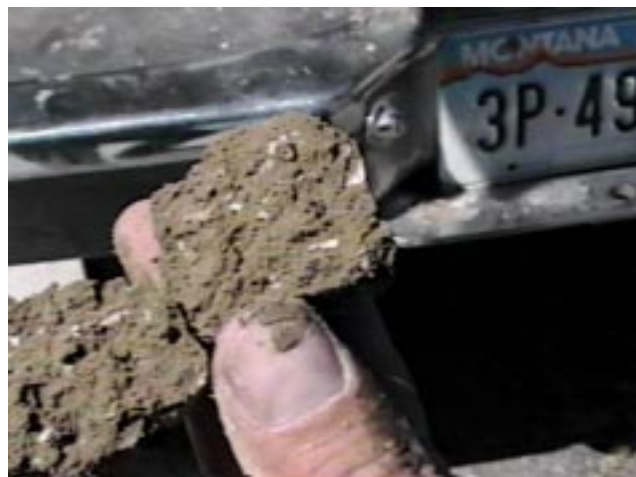
**PHOTOGRAPH NO. 2**  
White spots indicate water percolating through soil at 6-foot level.

The sample in photograph No. 2 was taken at 6-feet deep. This is approximately the depth of the basement. The water continues to “flow” through the concrete and then evaporate on the inside of the building. Crystals grow in the concrete causing it to spall and punch out. This occurs in the foundation wall as well as the concrete floor.

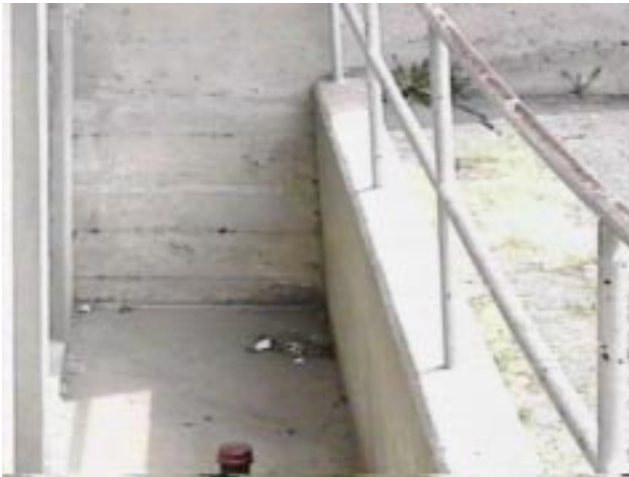
These window wells act as catch basins for rain and snow. Some are collapsing from the pressure of the soil. See photograph No. 3. All of them have cracks where water can seep into the soil nearby.

**PHOTOGRAPH NO. 3**  
**Window well retaining wall  
overturning from weight of soil.**

There can be no effective waterproofing without first dealing with the window wells. All but one of the window wells is in need of reconstruction anyway. Two are over 60-years old. Three have walls that are cracking and overturning from the weight of the soil.

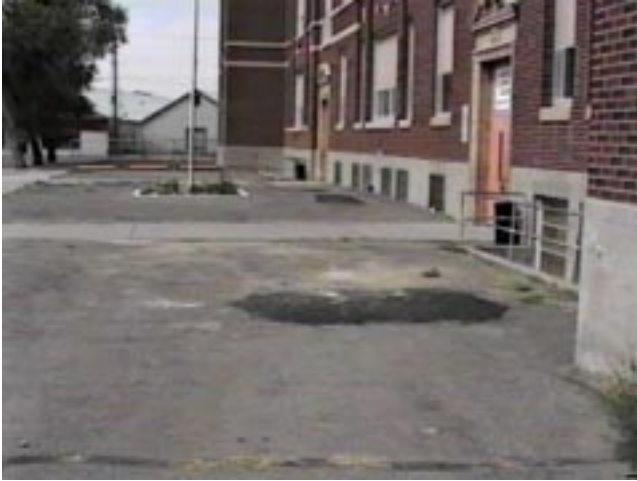
In addition, the asphalt playground around them is sloping towards the building in many places. See photograph No. 4. This allows water to pond around the base of the building and enter the ground through cracks in the asphalt and concrete.

**PHOTOGRAPH NO. 4**  
**Water ponds at many areas around base of building and window wells due to flat ground surface.**

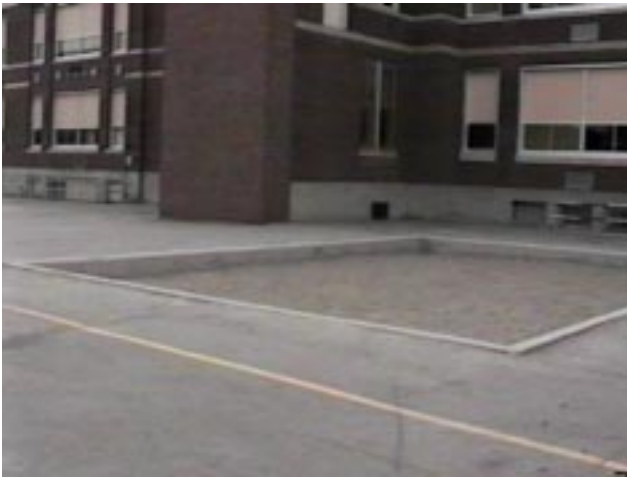
Also, the wind blows sand from the large play area next to the building into the window wells. See photograph No.5. This can plug the drains. If the window well drains are plugged, they can fill and leak water into the ground through the cracks in the concrete.

**PHOTOGRAPH NO. 5**  
**Wind blows sand from sandbox to window wells.**

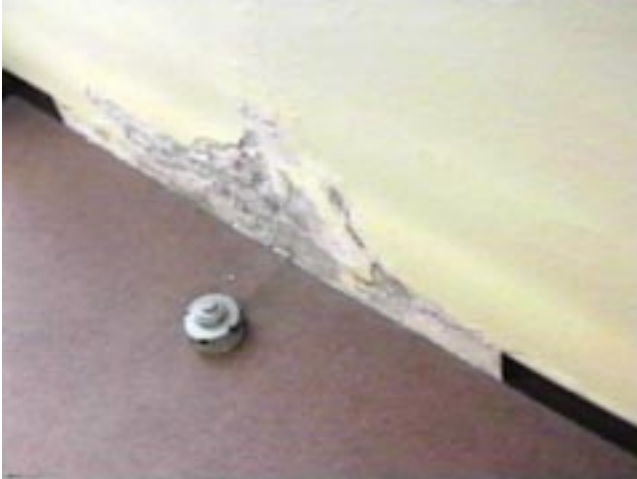
Another problem, that is associated with moisture in the ground, is the sewer lines in and around the building. A large wet spot occurs on the carpet during a heavy rain storm exactly where the sewer line exits the building below grade. See photograph No.6.

**PHOTOGRAPH NO. 6**  
**Clean-out where sewer exits  
basement of Garfield Elementary.**

This is the music room. This room smells of sewage much of the year. Our investigation has revealed that, most likely, there is only one 6-inch line carrying the sanitary and storm water for the entire building. All the roof drains, sinks and toilets; all of the window wells and the stair well seem to be draining into this one 6-inch cast iron line.

When the sewer line leaves the building, it changes to an 8-inch clay tile line which runs to the manhole in the street. During a heavy rain, one 6-inch pipe would have difficulty carrying the water from the entire roof area and other normal building activity. This could cause the line to pressure up and leak at the weakest point - the connection with the clay tile pipe just outside the music room. It is possible the sewer is leaking below grade in other places.

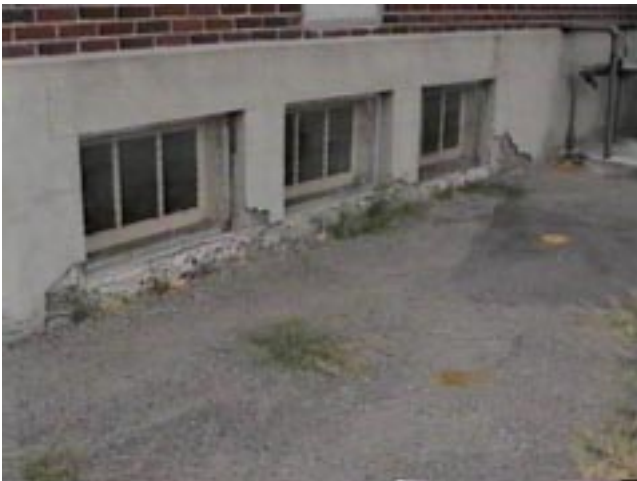
Concrete deterioration is not limited to the inside. See photograph No. 7. Snow piles and standing water can cause this deterioration.

**PHOTOGRAPH NO. 7**  
**East side of Garfield Elementary  
School.**

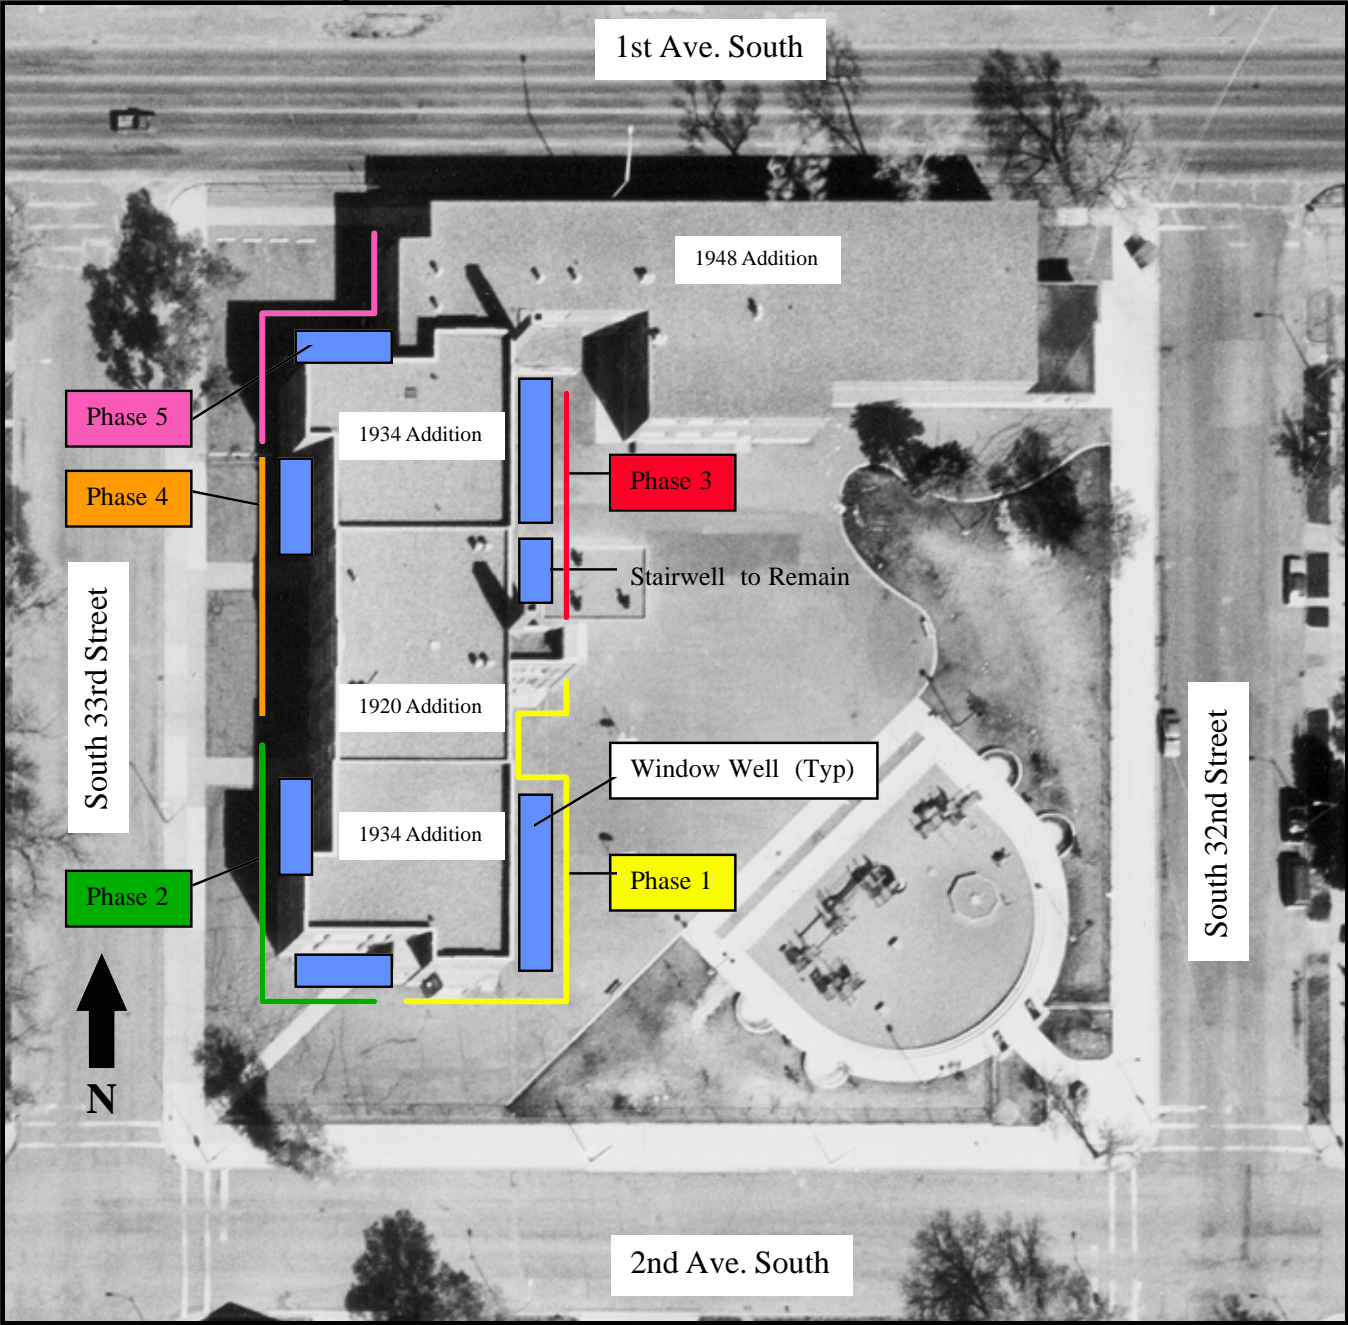
Garfield Elementary School: Reconstruction of Window Wells

Each phase represents \$50,000 of construction costs for window well reconstruction, waterproofing exterior of building wall below grade, and reconstruction of concrete basement floor. See C-2 for basement floor areas.

- Reconstruct leaking and cracked concrete window well and nearby step.
- Waterproof exterior wall of building below grade.
- Connect window well drains to sewer.
- Reconstruct concrete floor in music room and some severely damaged floor areas on the west side.
- Restore the concrete walls in those areas.
- Repair existing sewer line under floor in music room.
- Verify construction costs for future phases.
- Fine tune construction techniques and documents for future phases.

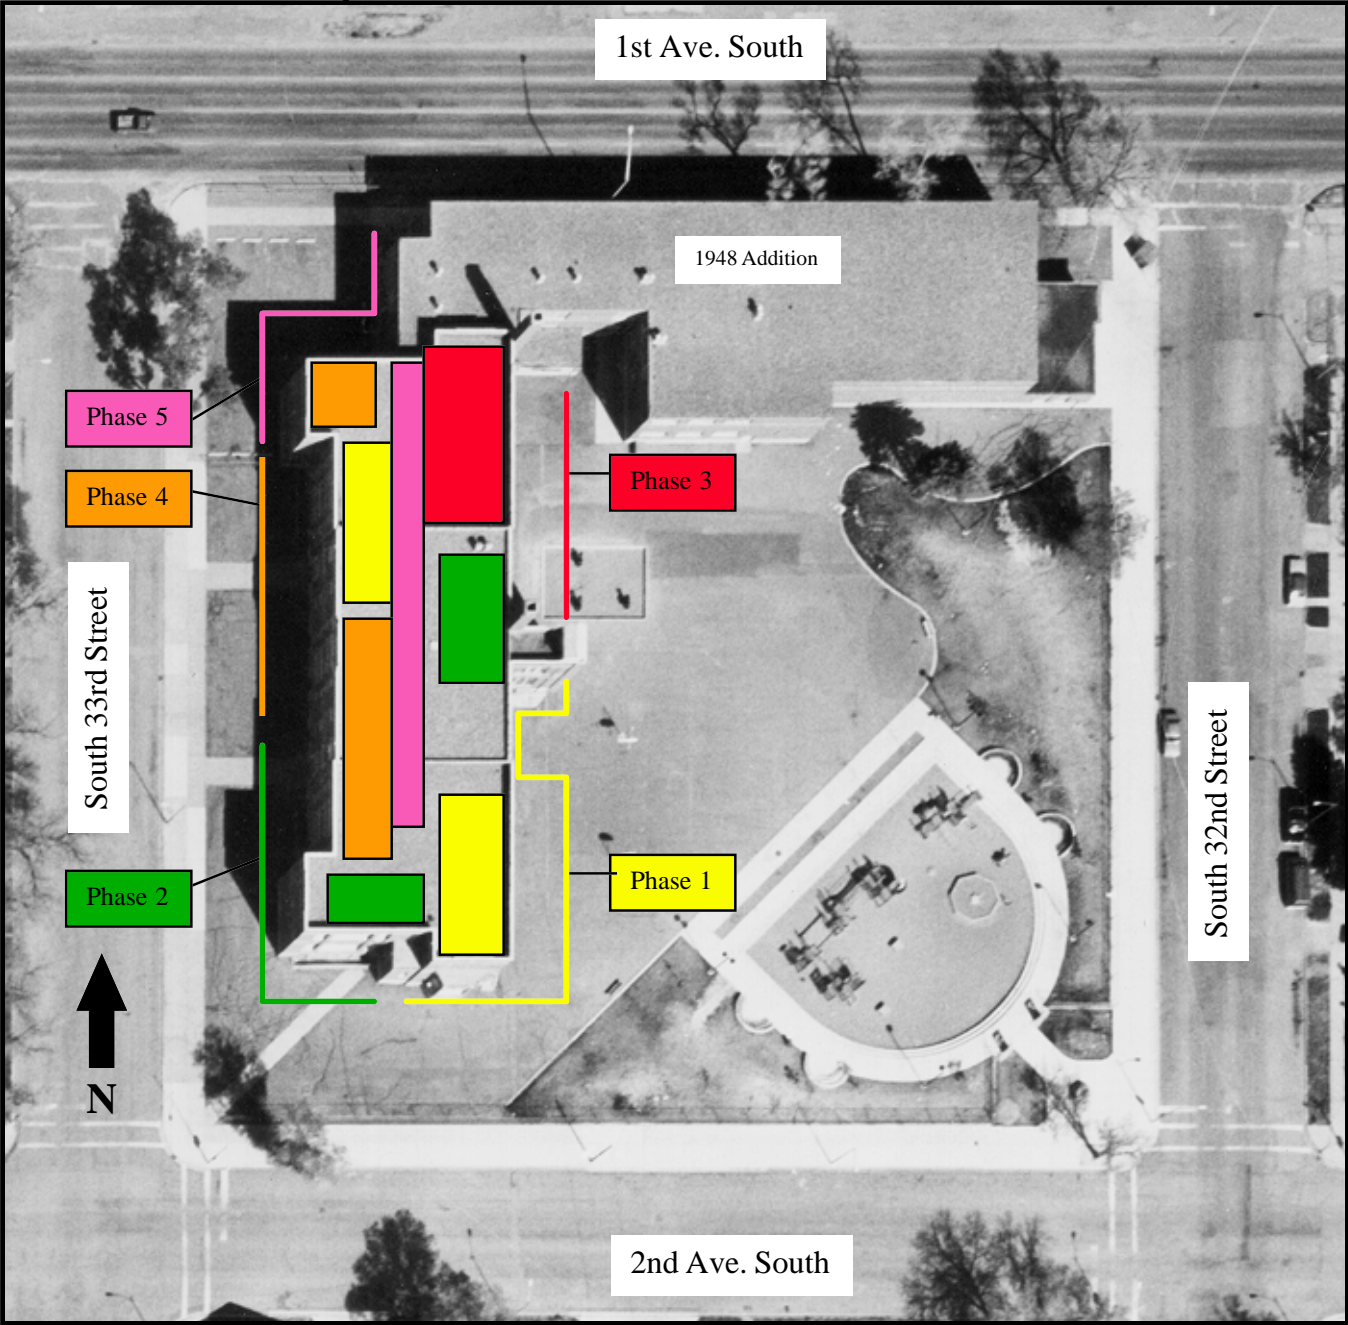
Garfield Elementary School: Reconstruction of Basement Floors

All concrete basement floor reconstruction costs are included in the cost of reconstruction of window well and below grade waterproofing shown on C-1.

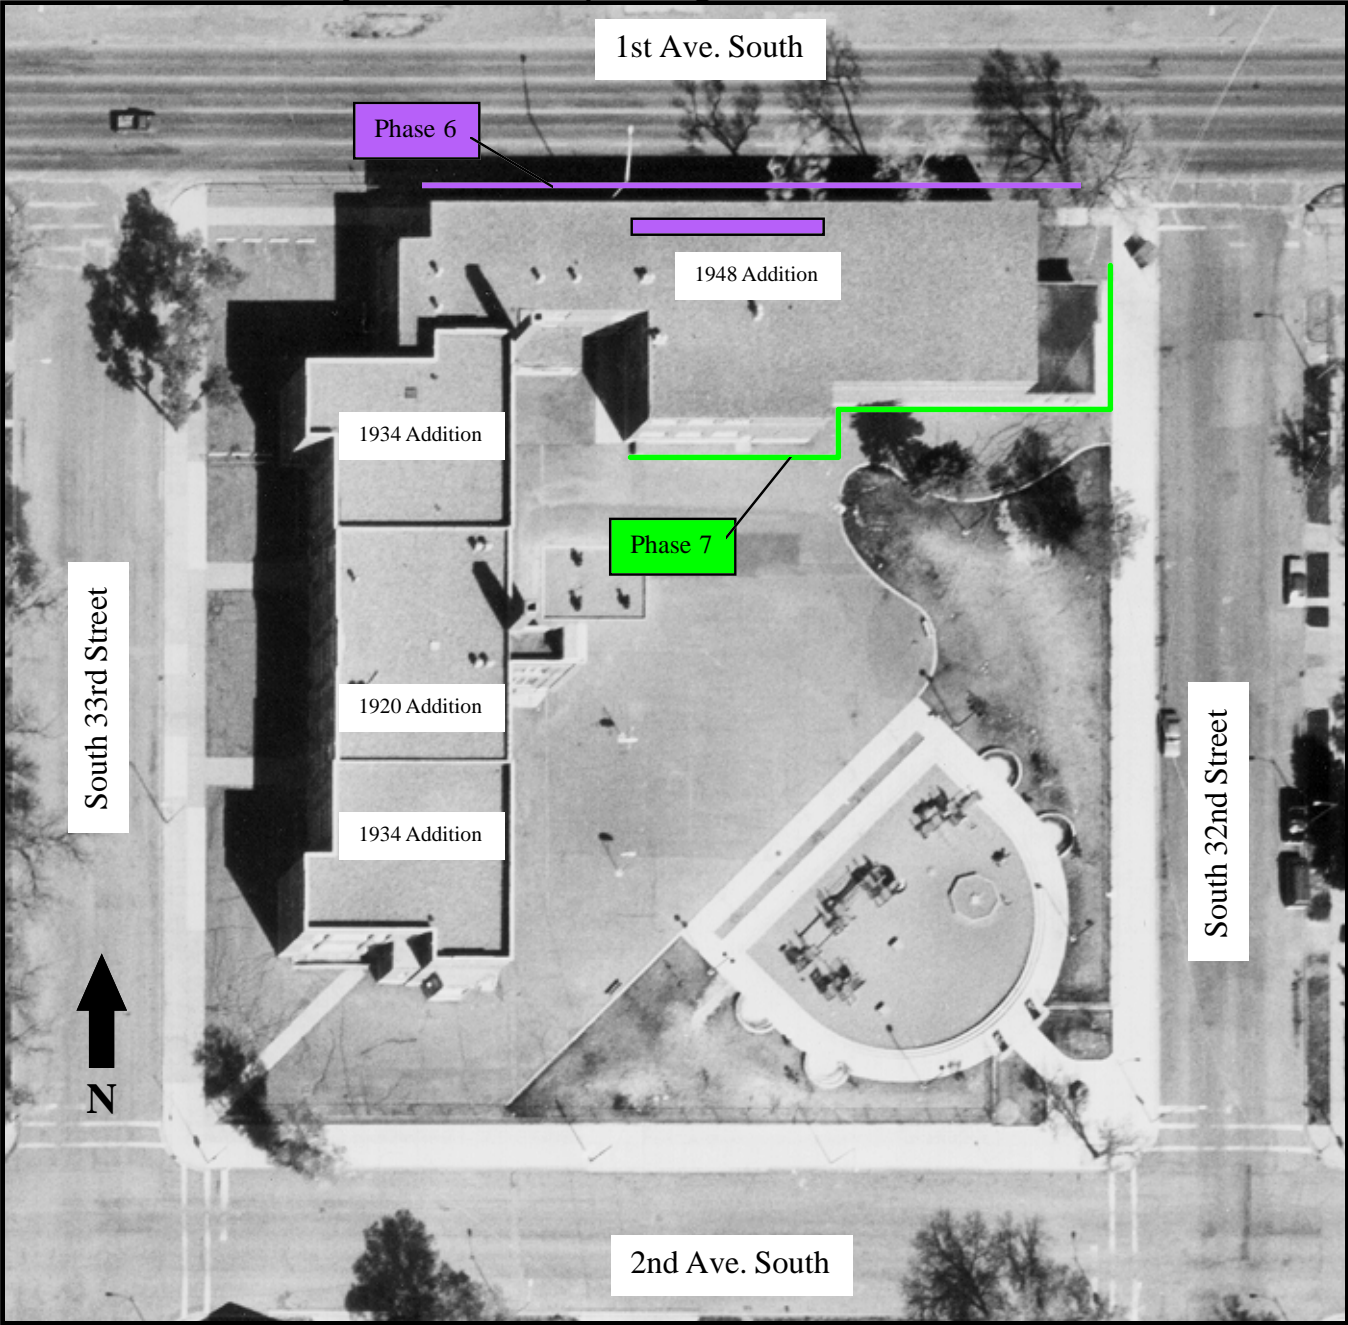
Garfield Elementary School: Waterproofing 1948 Addition

Each phase represents \$50,000 of construction costs for waterproofing below grade exterior of building wall and reconstruction of concrete sidewalk and some reconstruction of concrete floors in steam tunnels in phase 6.

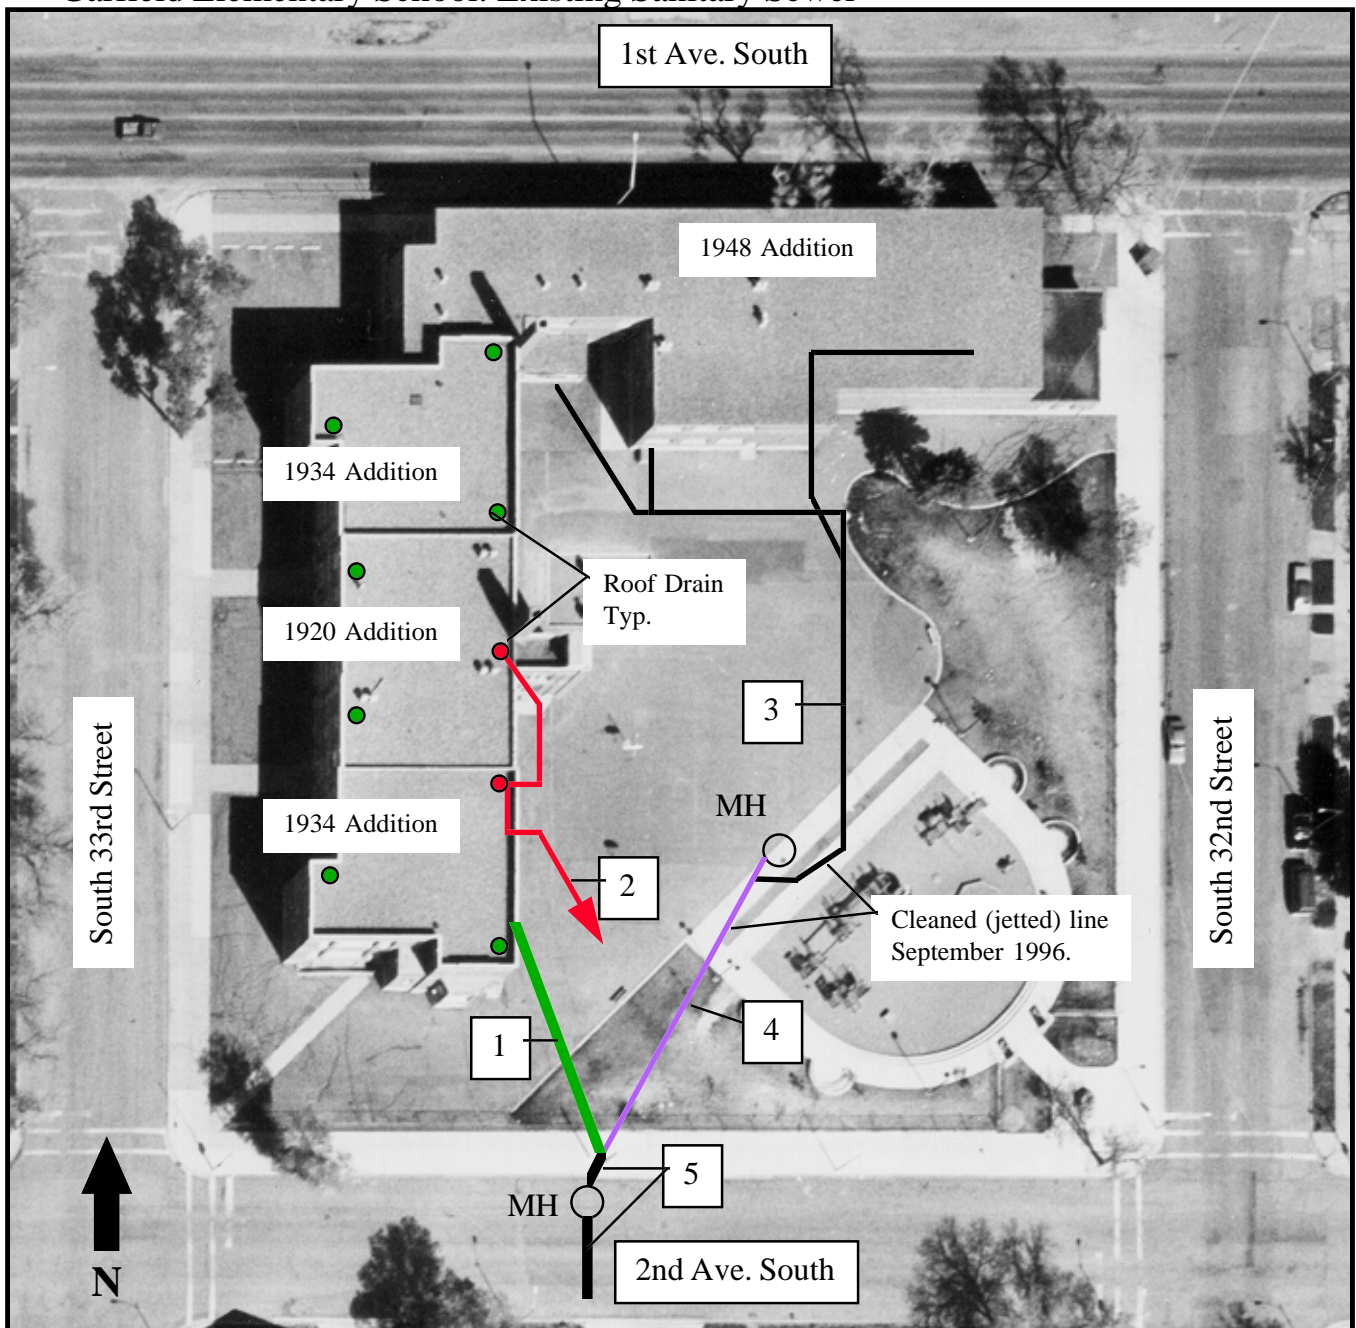
# Garfield Elementary School: Existing Sanitary Sewer

The main sewer line from the 1920 and 1934 additions is overloaded in times of heavy rains. This line runs southeast out of the building beneath the music room. See green line on S-1. During a heavy rain, according to my estimate, this 6-inch pipe can be at capacity from just seven roof drains and five window wells. (One window well has been disconnected and two roof drains use another line.)

The 6-inch line from the manhole in the yard to the manhole in 2nd Avenue was probably the sewer line for the 1902 original building (razed in 1981). See purple line on S-1. This section of sewer line needs replacing. It has many low spots and could be a source of an emergency at an inopportune time. I recommend replacing it within 5-years. This could cost \$15,000.

There is another 6-inch line handling one roof drain on the east side of the 1920 addition and one roof drain on the east side of the 1934 south addition. See red line on S-1. This

pipe twists, turns, goes back under the building and back out. It has been repaired with PVC indicating a possible break when the new gas line was installed. This 6-inch line is 18-inches deep and then drops to 5 to 6-feet deep and connects to the original 6-inch (purple) sewer line between the manhole in the yard and the manhole in 2nd Avenue.

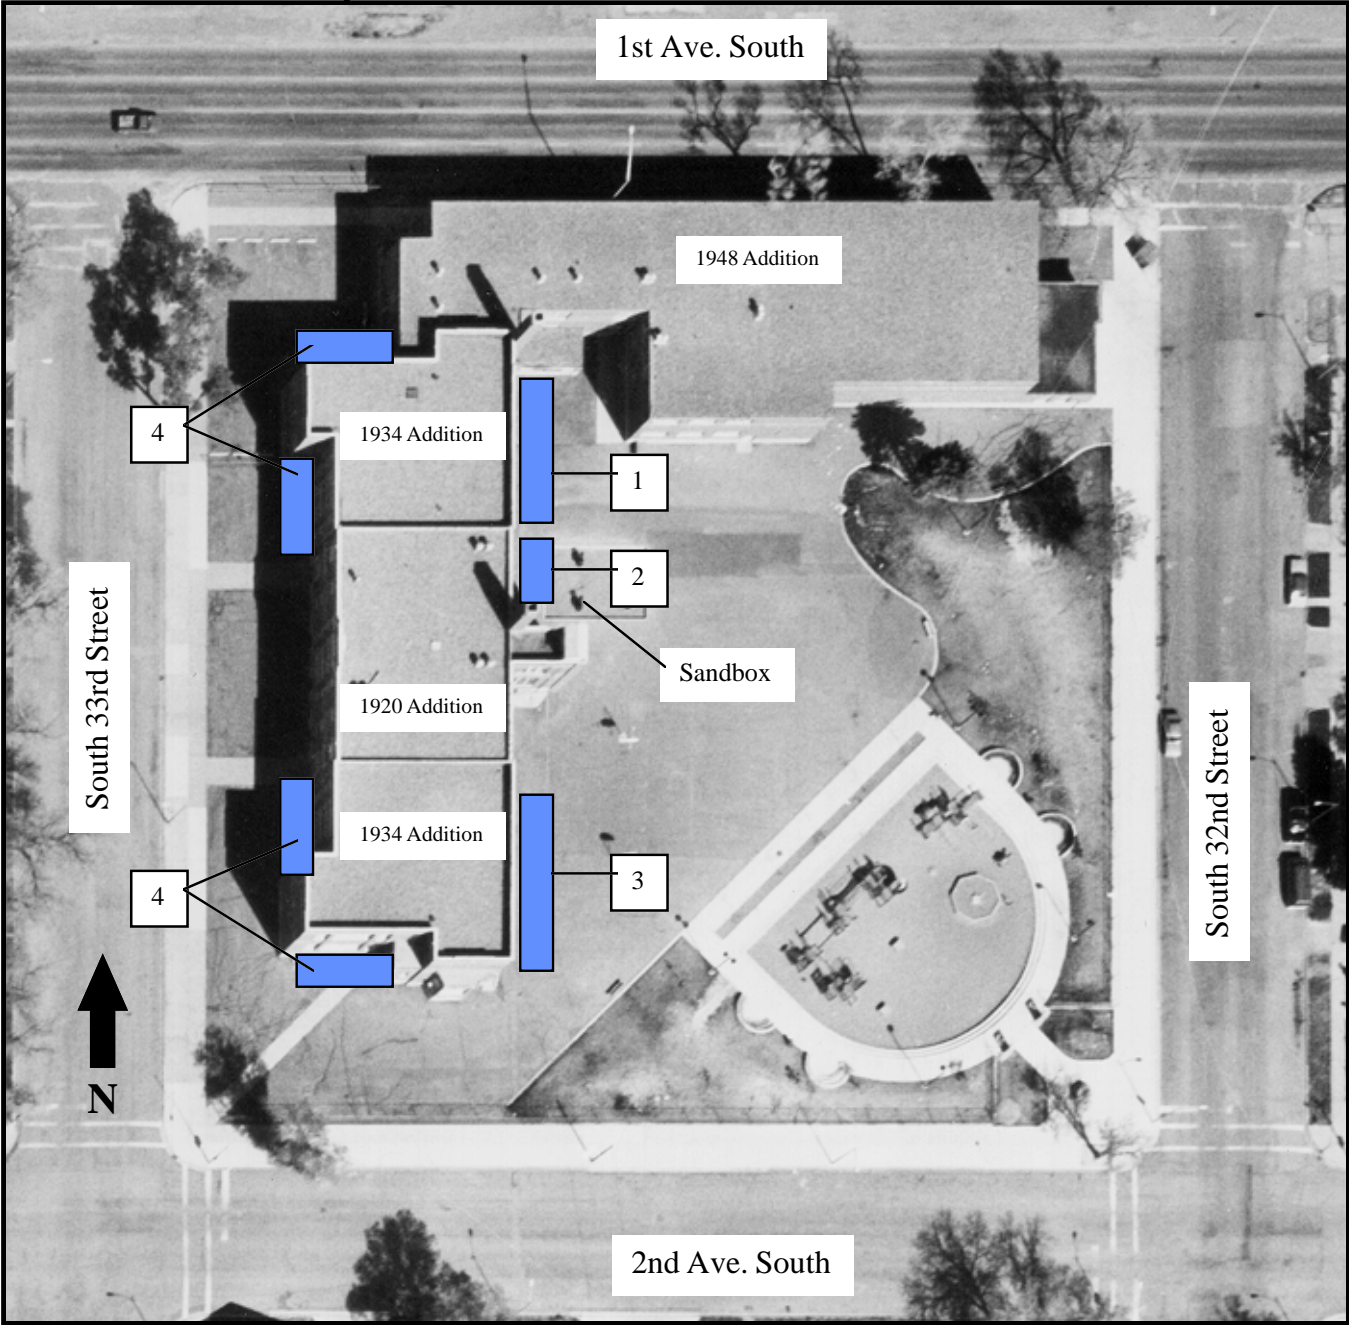
# Garfield Elementary School: Maintenance of Window Wells

All of the window wells and their drain lines have been cleaned and checked with water. See blue boxes on S-5. All but one drain well now. The window well next to the music room (east side) has no connection to the sewer that we can find. This must have been

disconnected from under the music room floor and could be the source of our leak and sewer smell.

It was found that one drain line in the window well was capped and one ended in mud. There is a hole in the concrete next to the drain that water goes down readily. This hole might be the reason water is getting into the music room. The wet carpet that smells of sewer may be from a combination of the sewer line and the window well leaking.

4' x 60' x 3'-6" deep window well (1934). Concrete bottom and drains reconstructed unknown date. Shovels full of sand cleaned out Oct. 22, 1996. Drains cleaned and work well.
- 2

4' x 25' x 6'-0" deep stairwell (1934). Concrete walls and bottom reconstructed in 1989. Full of trash and sand. Cleaned Oct. 22, 1996.
- 3

4' x 70' x 3'-6" deep window well (1934). Not connected to any sewer. Cleaned Oct. 22, 1996. North drain hits mud after 2'. South drain dead ends after 2'. Water runs into small hole in concrete next to drain into the soil.
- 4

Four 4' x 28' x 3'-6" deep window wells (1955 remodel). Cleaned Oct. 22, 1996. Drains work well. All but north well needs reconstruction due to cracking concrete and overturning walls.

A preventive maintenance program should be implemented at Garfield. The sewer lines, stairwell, window wells and their drains should be cleaned periodically. The sewer lines should be jetted once a year. The stairwell, window wells and their drain lines should be cleaned more often. If the sandbox is left in place, cleaning should be done monthly. If the sandbox is removed, cleaning could be done quarterly. An inspection program should be implemented to verify if cleaning is being performed adequately and to adjust the cleaning schedule to maximize effectiveness.

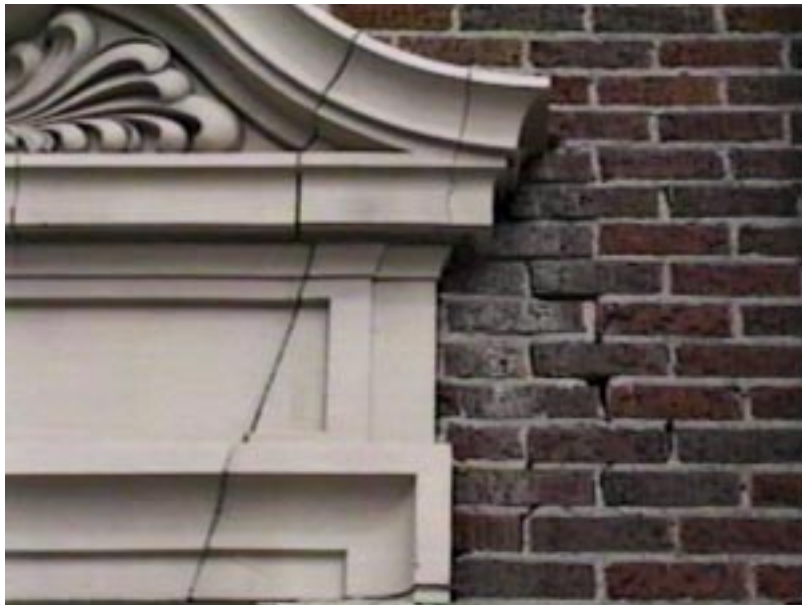
**The exterior of Garfield School is in need of maintenance.  
This photo shows brick that needs repointing.**

At the same time start on the worst areas of brick deterioration:

- Clean brick, stone and terra cotta.
- Repoint brick.
- Apply sealant to joints.
- Apply clear waterproofing to face brick.
