Building Research Institute  
of Montana

Special Report: Water Problems at  
Riverside Middle School

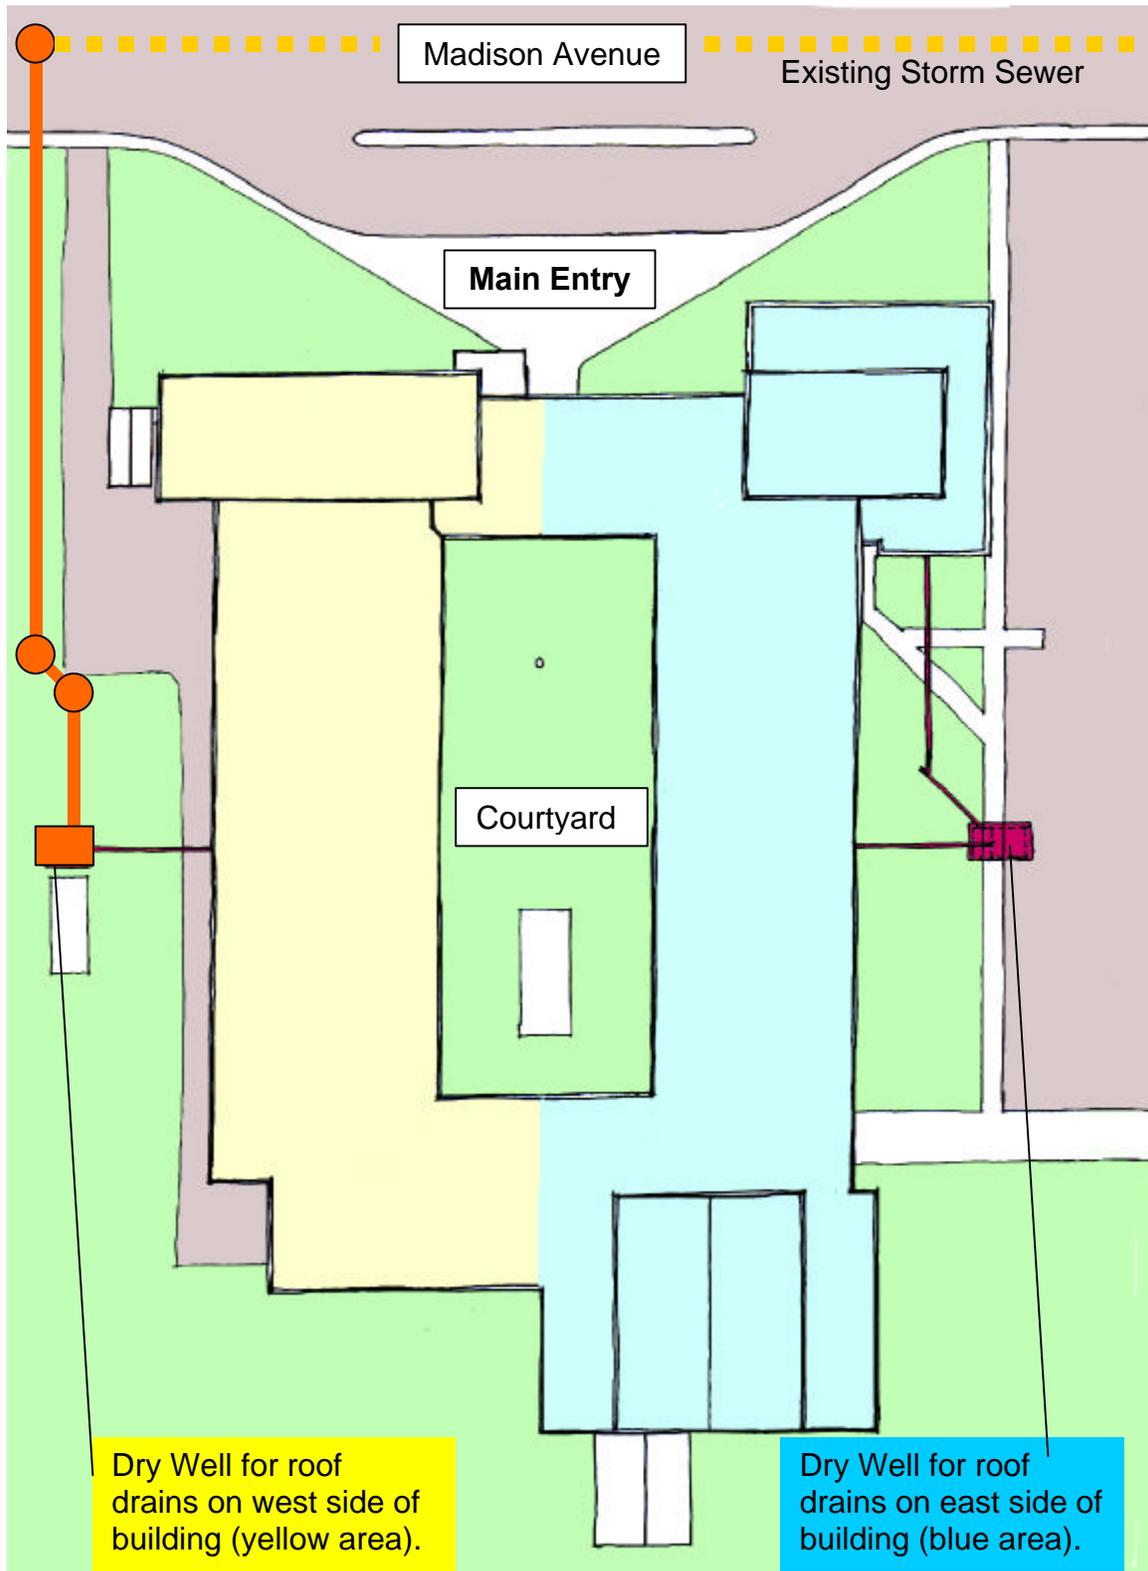
**Site Plan** (Not To Scale)

a pipe full of water all the way to the drywell starting at approximately the edge of the asphalt drive 24-feet from the building. The last 20-feet of pipe to the drywell was full of water. This means, as suspected, the drywell has stopped functioning. During a heavy rainstorm or sudden snowmelt water could back up the restricted pipe and come into the building.

Dry Well for roof drains on west side of building (yellow area).

Dry Well for roof drains on east side of building (blue area).

Rainwater needs to be stopped from entering the building. We need to collect and disperse the rainwater more effectively. To do this, a number of tasks will have to be performed. The research team recommends replacing the drywells on both sides of the school with new drywells and connecting them to the city storm sewer. The storm sewer is located in Madison Avenue to the north of Riverside. It was installed after the school was built. This allows us to use the drywell to "recharge" the ground with rainwater as required and have the excess run-off go to the city storm sewer.

**Phase 1 (orange): \$30,500**

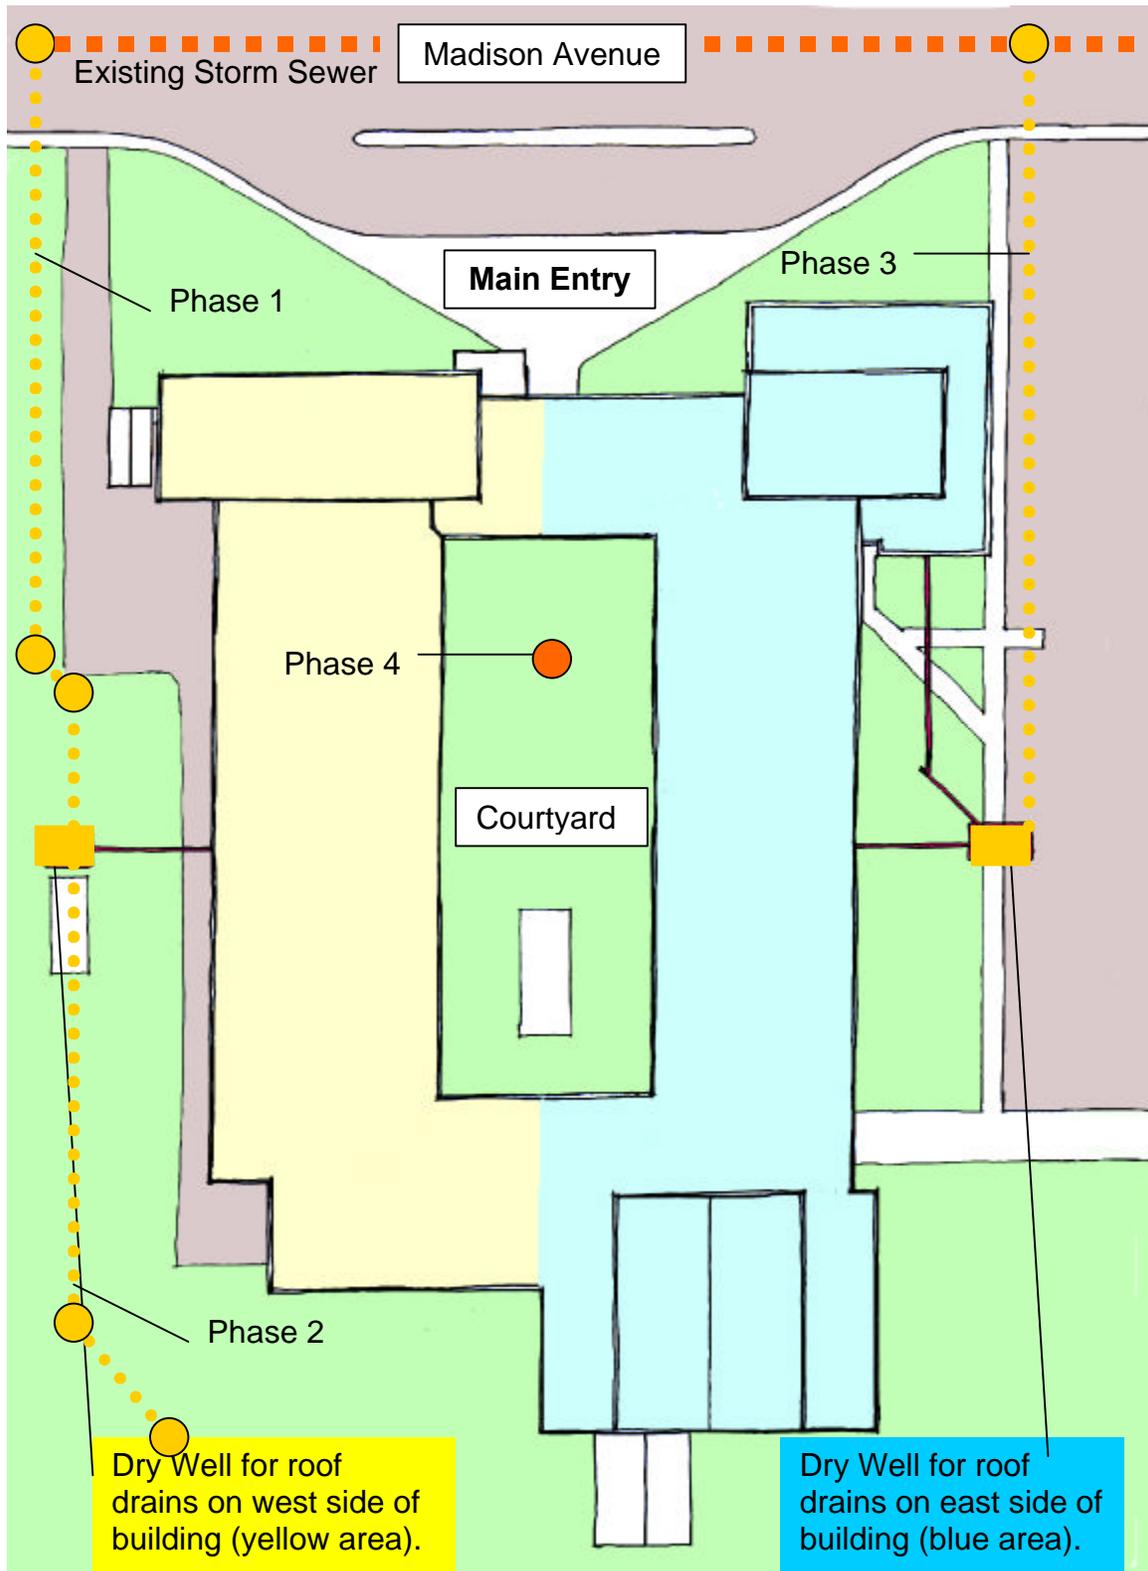
Site Plan (Not To Scale)

The problem with the courtyard is rainfall. Stories were related that the French Drain fills with water and overflows. With such a large area, this courtyard could collect 38,000 gallons of water if we received our maximum rainfall. One of the two French Drains has been covered with a greenhouse so it is unavailable to collect water. The rock voids in the usable one are probably filled with silt from many years of use.

Also, the French Drain in the courtyard should be replaced to make sure we are collecting that water properly. It needs to be larger.

Phase 4 (orange): \$6,600
