Building Research Institute of Montana

Special Report: Water Problems at Riverside Middle School

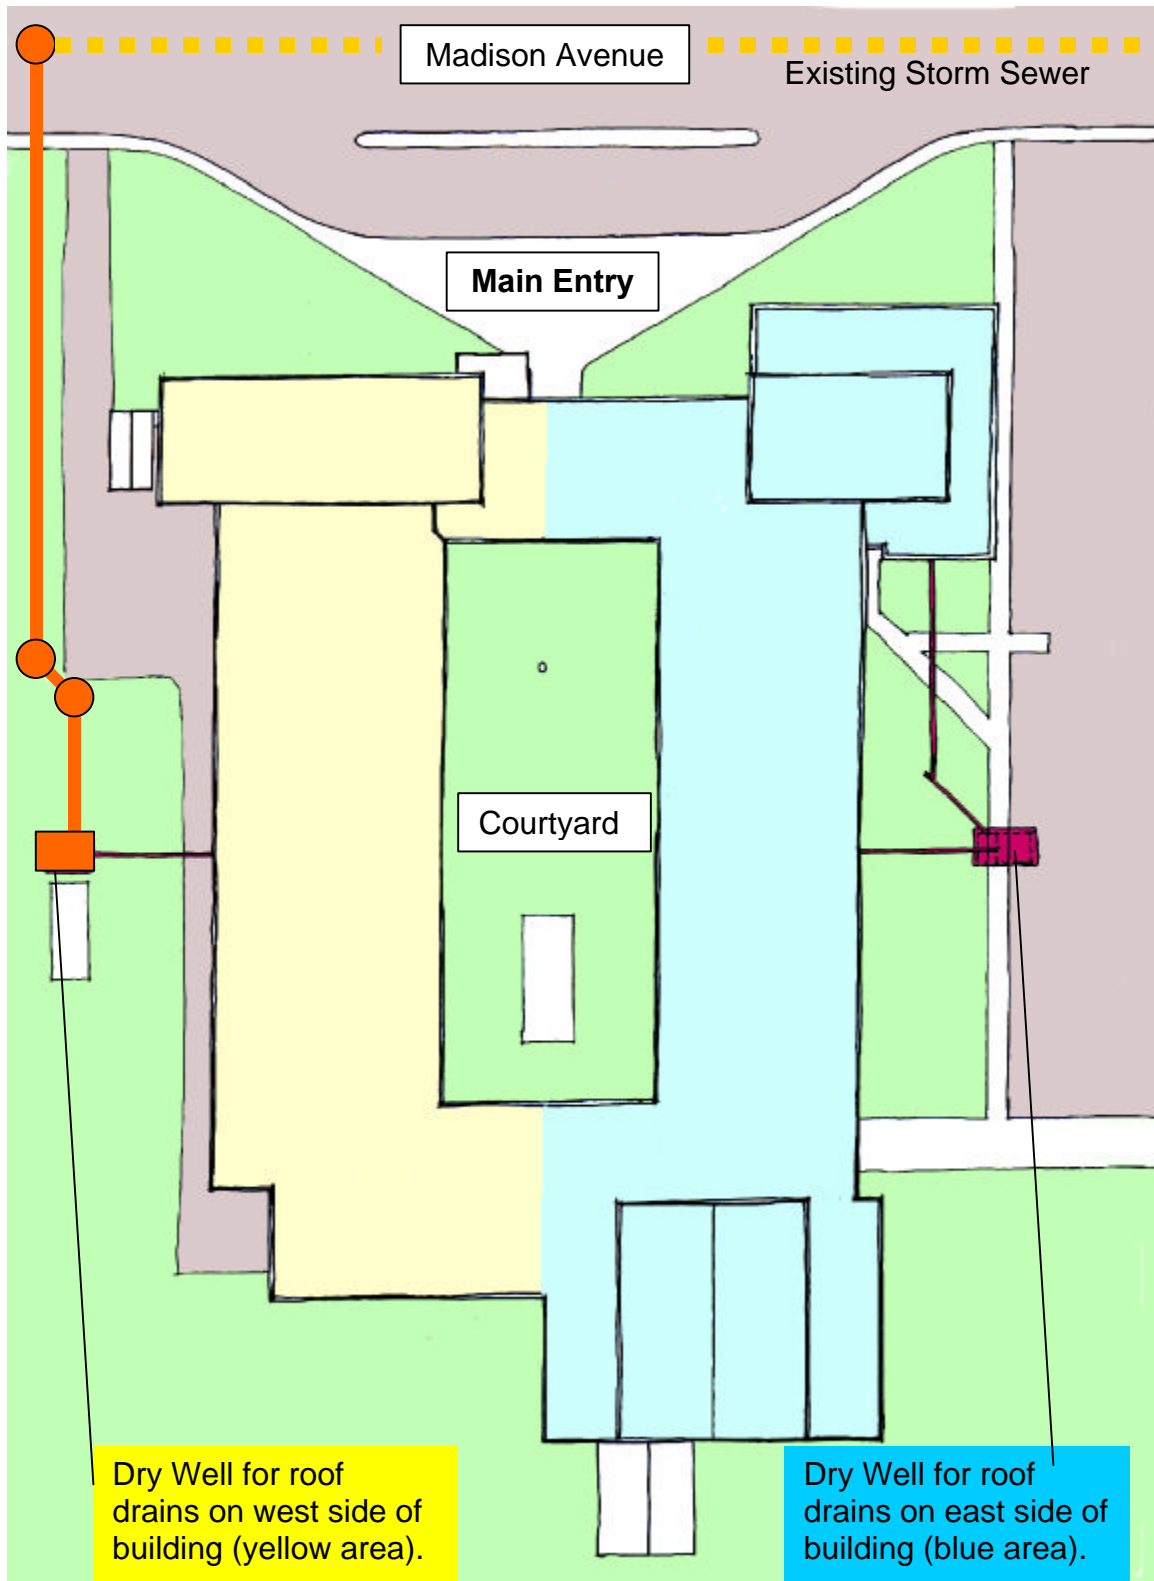
Site Plan (Not To Scale)

a pipe full of water all the way to the drywell starting at approximately the edge of the asphalt drive 24-feet from the building. The last 20-feet of pipe to the drywell was full of water. This means, as suspected, the drywell has stopped functioning. During a heavy rainstorm or sudden snowmelt water could back up the restricted pipe and come into the building.

Dry Well for roof drains on west side of building (yellow area).

Dry Well for roof drains on east side of building (blue area).

Rainwater needs to be stopped from entering the building. We need to collect and disperse the rainwater more effectively. To do this, a number of tasks will have to be performed. The research team recommends replacing the drywells on both sides of the school with new drywells and connecting them to the city storm sewer. The storm sewer is located in Madison Avenue to the north of Riverside. It was installed after the school was built. This allows us to use the drywell to "recharge" the ground with rainwater as required and have the excess run-off go to the city storm sewer.

Phase 1 (orange): \$30,500

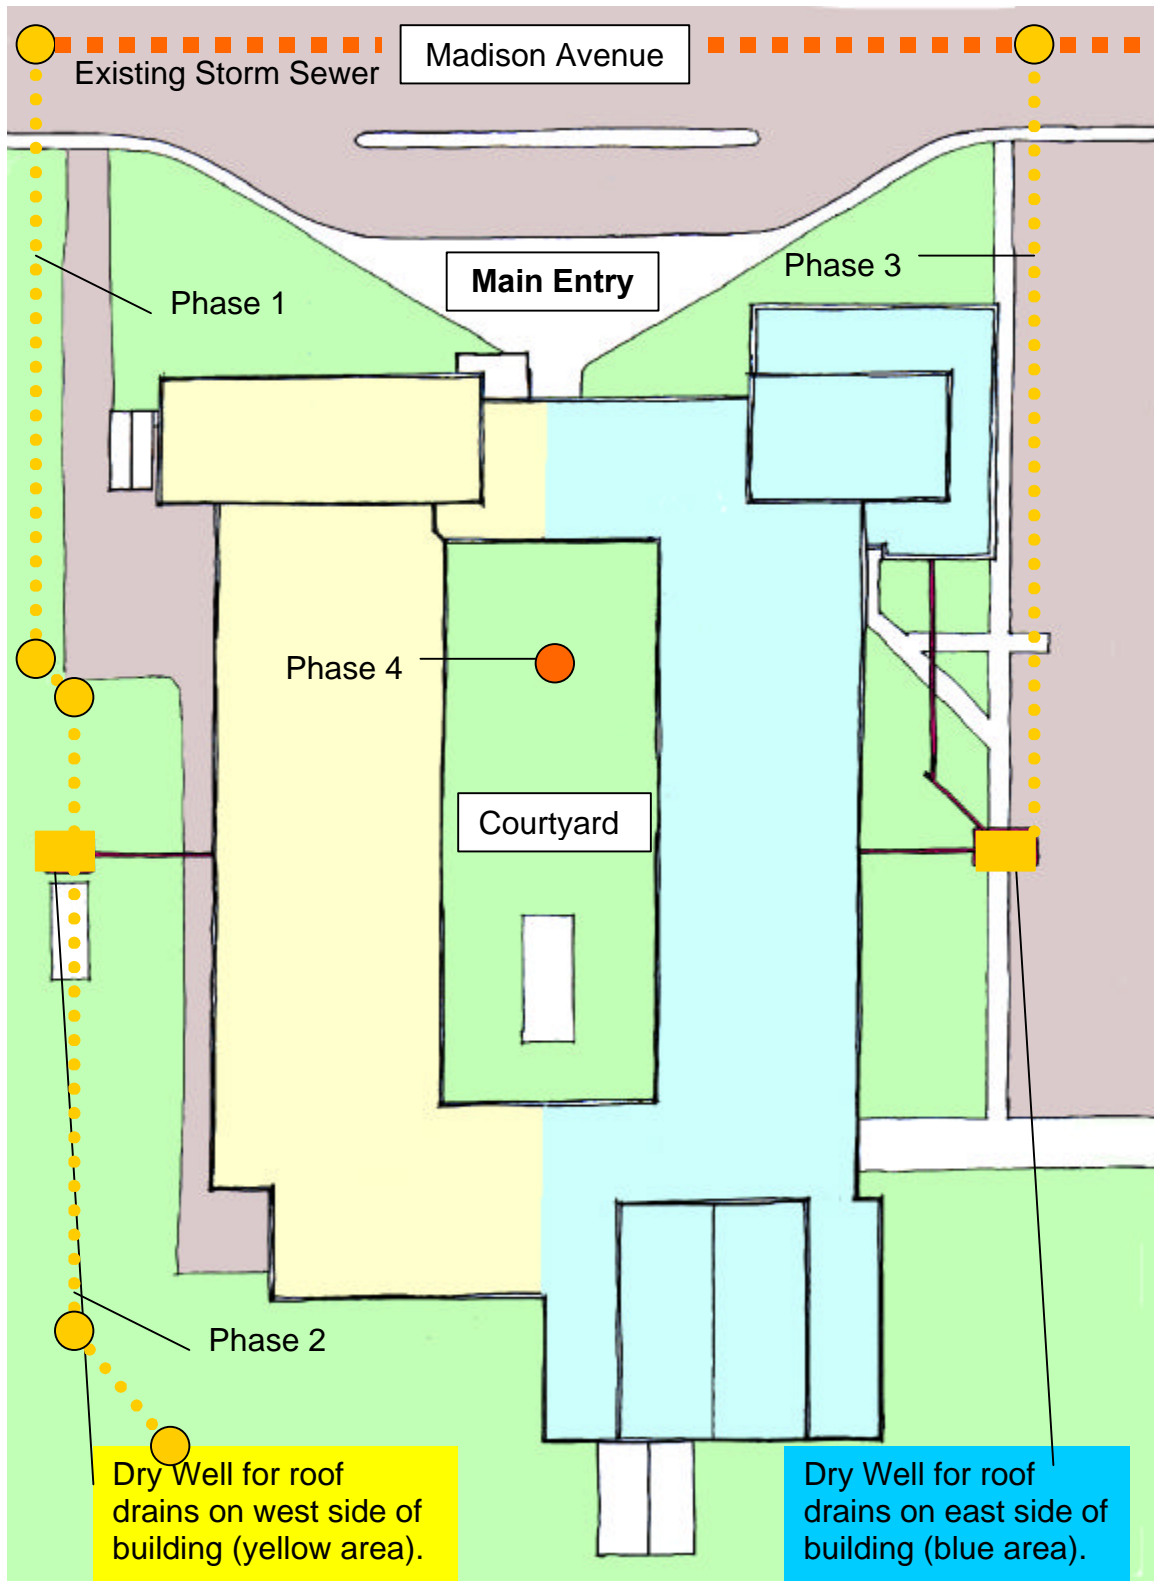
Site Plan (Not To Scale)

The problem with the courtyard is rainfall. Stories were related that the French Drain fills with water and overflows. With such a large area, this courtyard could collect 38,000 gallons of water if we received our maximum rainfall.

One of the two French Drains has been covered with a greenhouse so it is unavailable to collect water. The rock voids in the usable one are probably filled with silt from many years of use.

Also, the French Drain in the courtyard should be replaced to make sure we are collecting that water properly. It needs to be larger.

Phase 4 (orange): \$6,600
