**CRUMBLING CONCRETE  
GARFIELD ELEMENTARY SCHOOL  
REPORT AND BLUEPRINT FOR ACTION**

RE: Preliminary Report - Crumbling Concrete Walls - Basement of Garfield Elementary

## PRELIMINARY REPORT - CRUMBLING CONCRETE GARFIELD ELEMENTARY SCHOOL

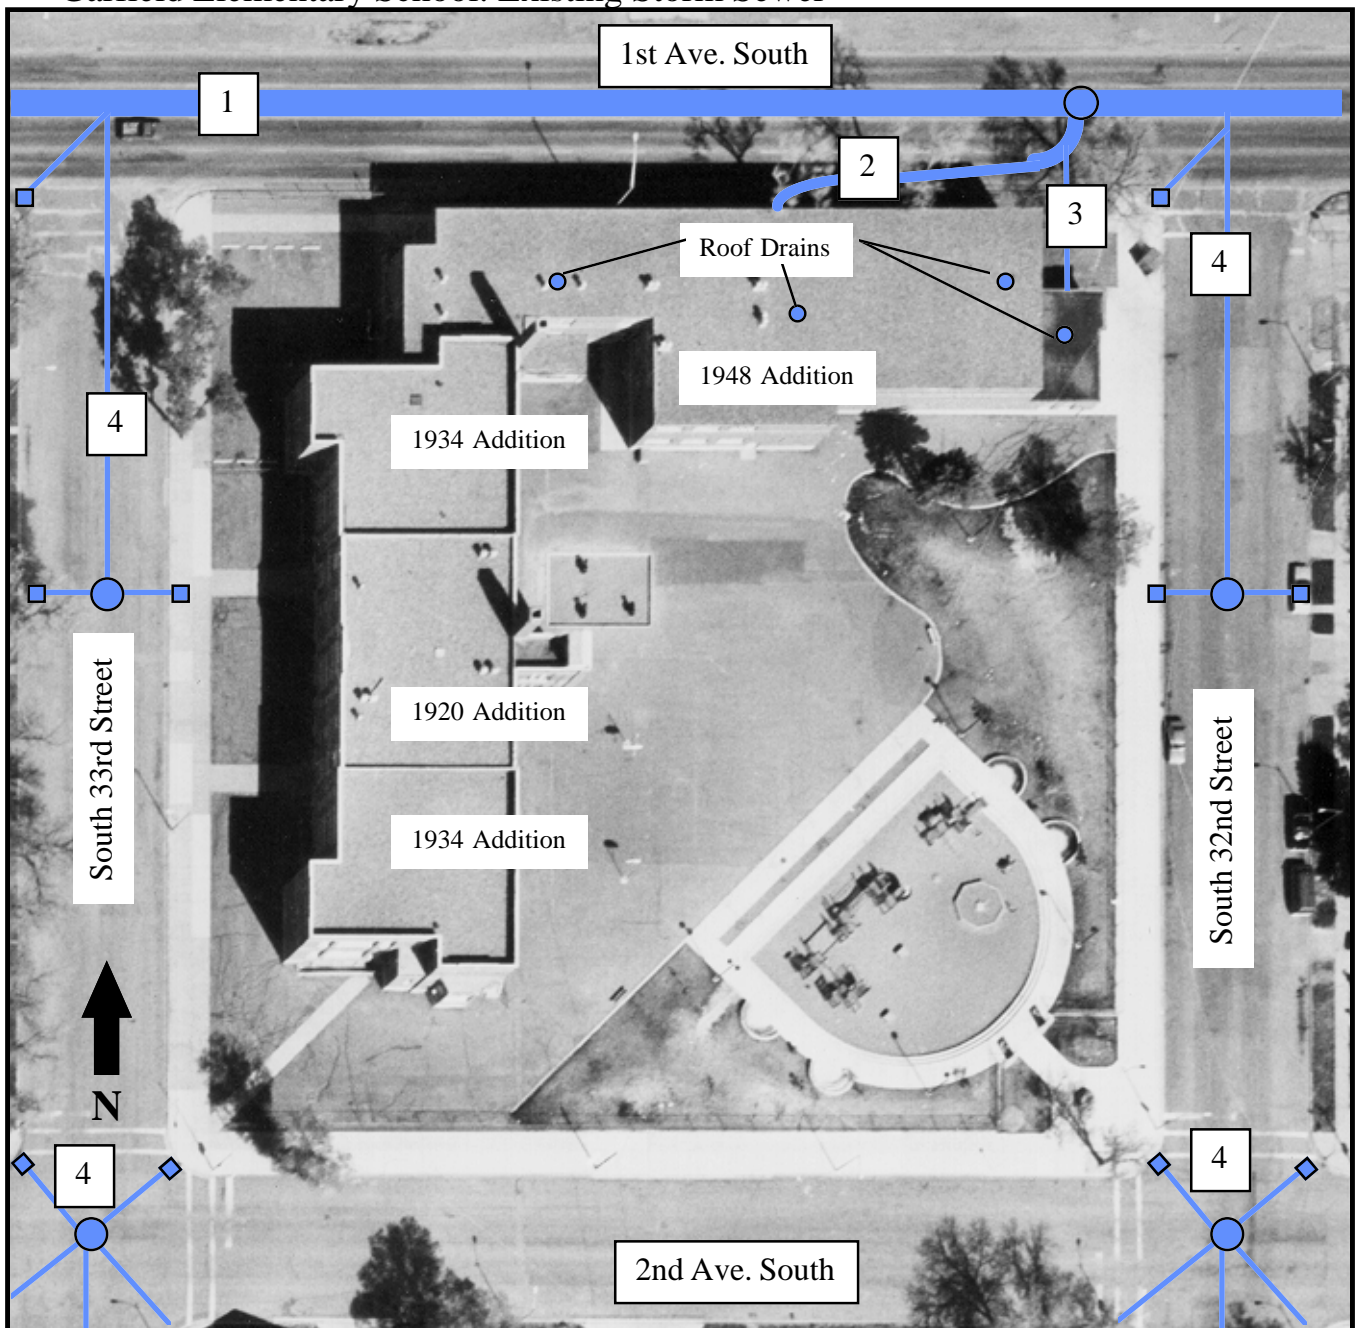
## Garfield Elementary School: Existing Storm Sewer

- 1 36-inch dia., 5-foot deep storm sewer built by MT Transportation Dept., maintained by City of Billings Public Works Department.
- 2 8-inch dia. into 10-inch dia., 5-foot deep storm sewer built in 1948 to handle roof drains of 1948 addition.
- 3 6-inch dia. into 10-inch dia, 5-foot deep storm sewer built in 1948 to handle roof drains of 1948 addition.
- 4 6-inch dia., 3-foot deep storm sewer built in 1932, maintained by City of Billings Public Works Department.

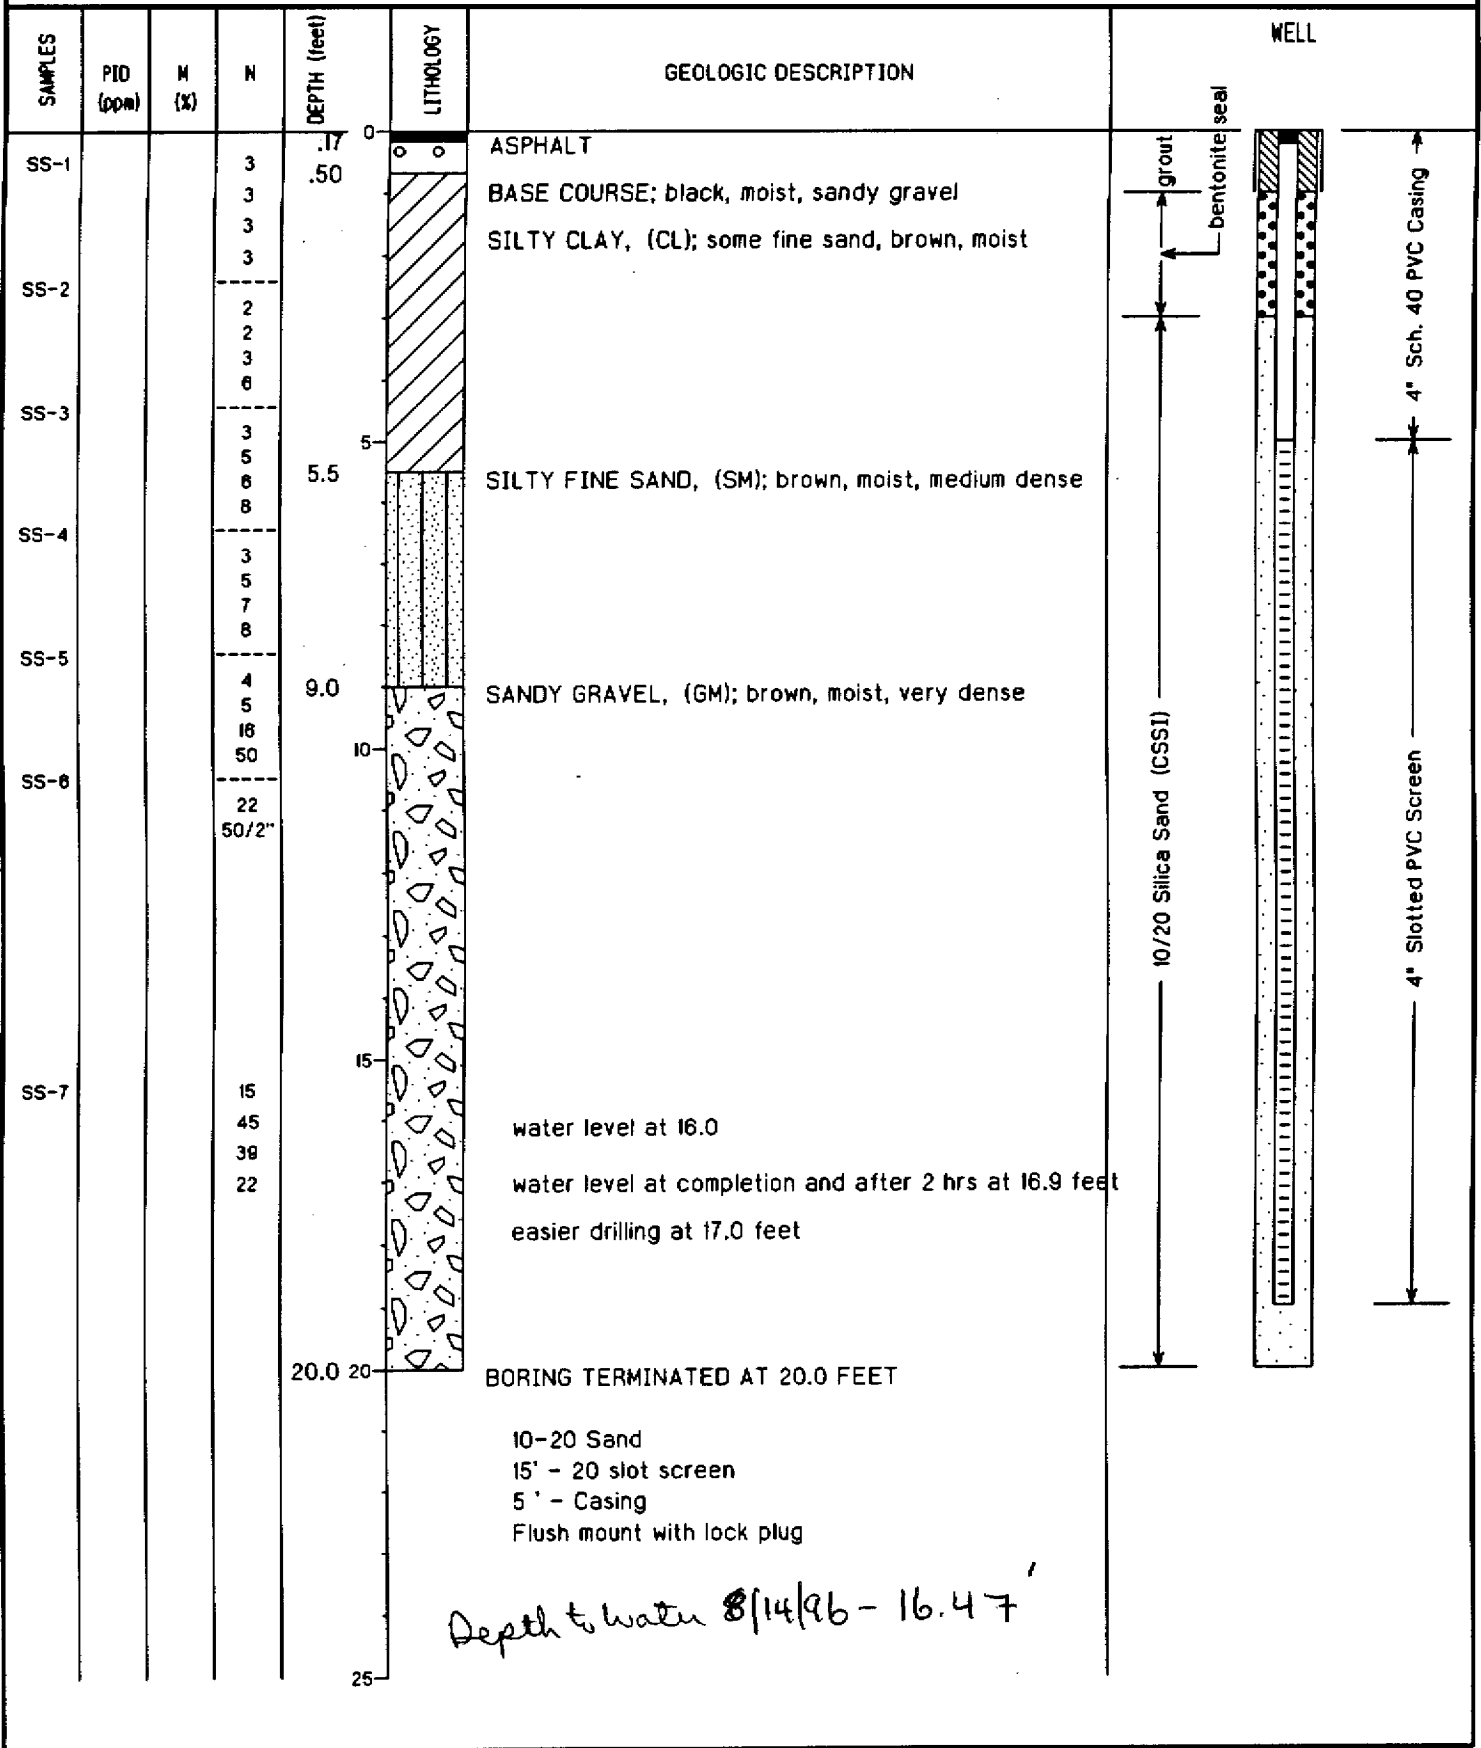
Project No. : 8B516.101  
 Project : GARFIELD SCHOOL  
 Location : BILLINGS, MT  
 Drill Date : 8/8/96  
 Drill Method : MOBILE B-47

Surface Elev. :  
 Drill Hole Location : NA  
 Total Depth : 10.0  
 Water Level (Date) : DRY (8/8/96)  
 Field Logged by : C. PETERSON
